ANNUAL REPORT FOR 2012

Ivy Gap Branch Site N Mitigation Site
Madison County
TIP No. R-2518A
COE Action ID: SAW-2007-2197-357/300
DWQ #: 20071134

Prepared By:
Natural Environment Section & Roadside Environmental Unit
North Carolina Department of Transportation
December 2012

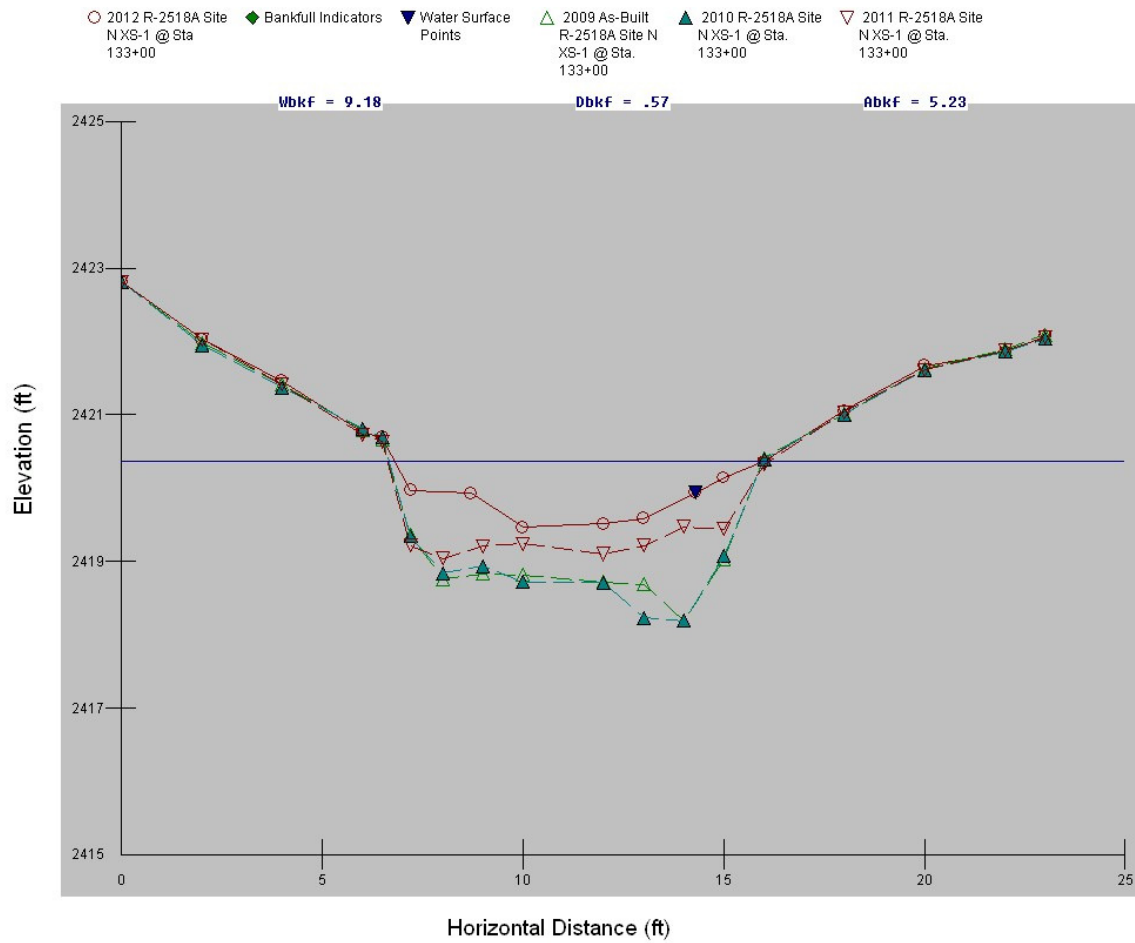
R-2518A Site N XS-1 @ Sta 133+00

Site N: Cross-Section #1 (Pool) Abbreviated Morphological Summary					
	2010	2011	2012	2013	2014
Bankfull Cross Sectional Area (ft ²)	14.26	12.34	5.23		
Maximum Bankfull Depth (ft.)	2.2	1.59	0.9		
Bankfull Mean Depth (ft.)	1.53	1.19	0.57		
Bankfull Width (ft.)	9.34	10.37	9.18

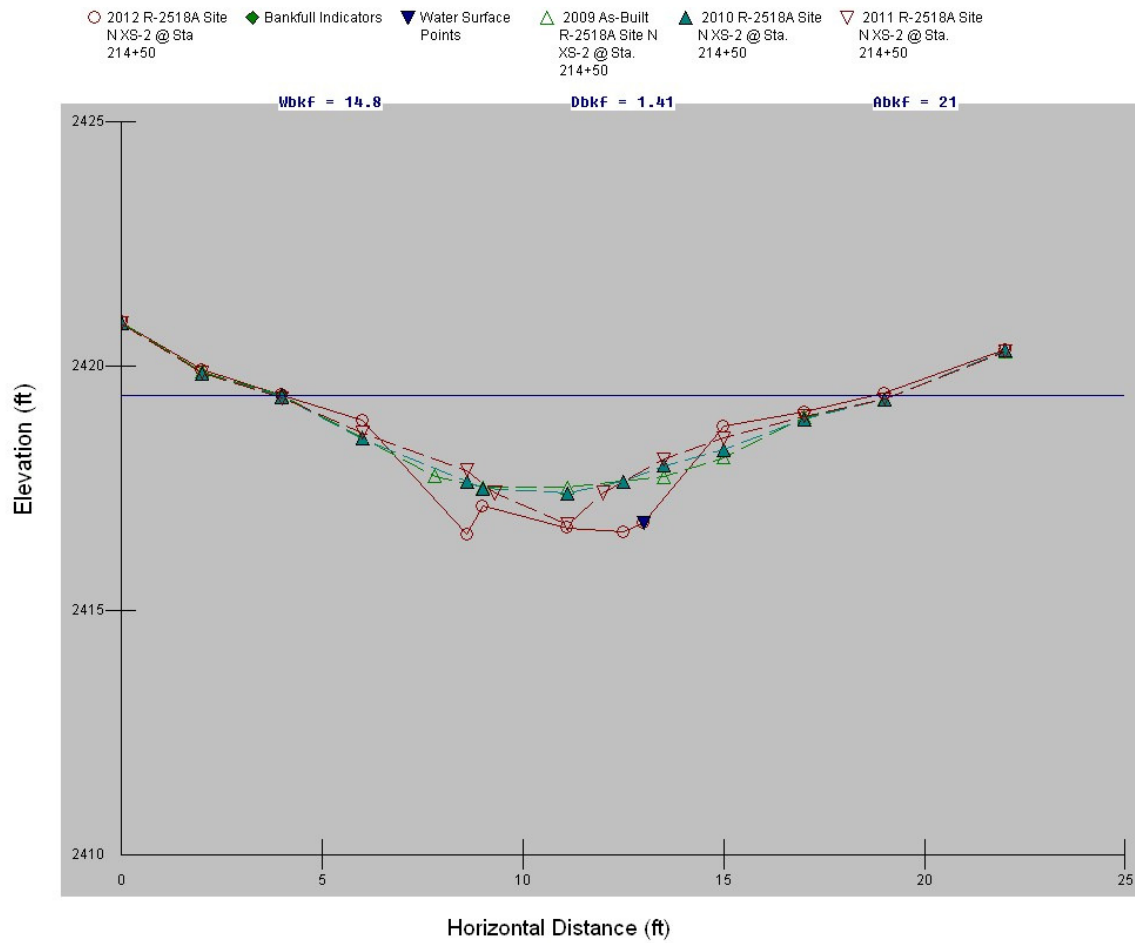
R-2518A Site N XS-2 @ Sta 214+50

Site N: Cross-Section #2 (Riffle) Abbreviated Morphological Summary					
	2010	2011	2012	2013	2014
Bankfull Cross Sectional Area (ft ²)	17.17	11.37	20.96		
Maximum Bankfull Depth (ft.)	1.98	2.21	2.85		
Width of the Floodprone Area (ft.)	22	22	22		
Bankfull Mean Depth (ft.)	1.13	0.95	1.41		
Width/Depth Ratio	13.43	12.59	10.52		
Entrenchment Ratio	1.45	1.84	1.48		
Bankfull Width (ft.)	15.18	11.96	14.84

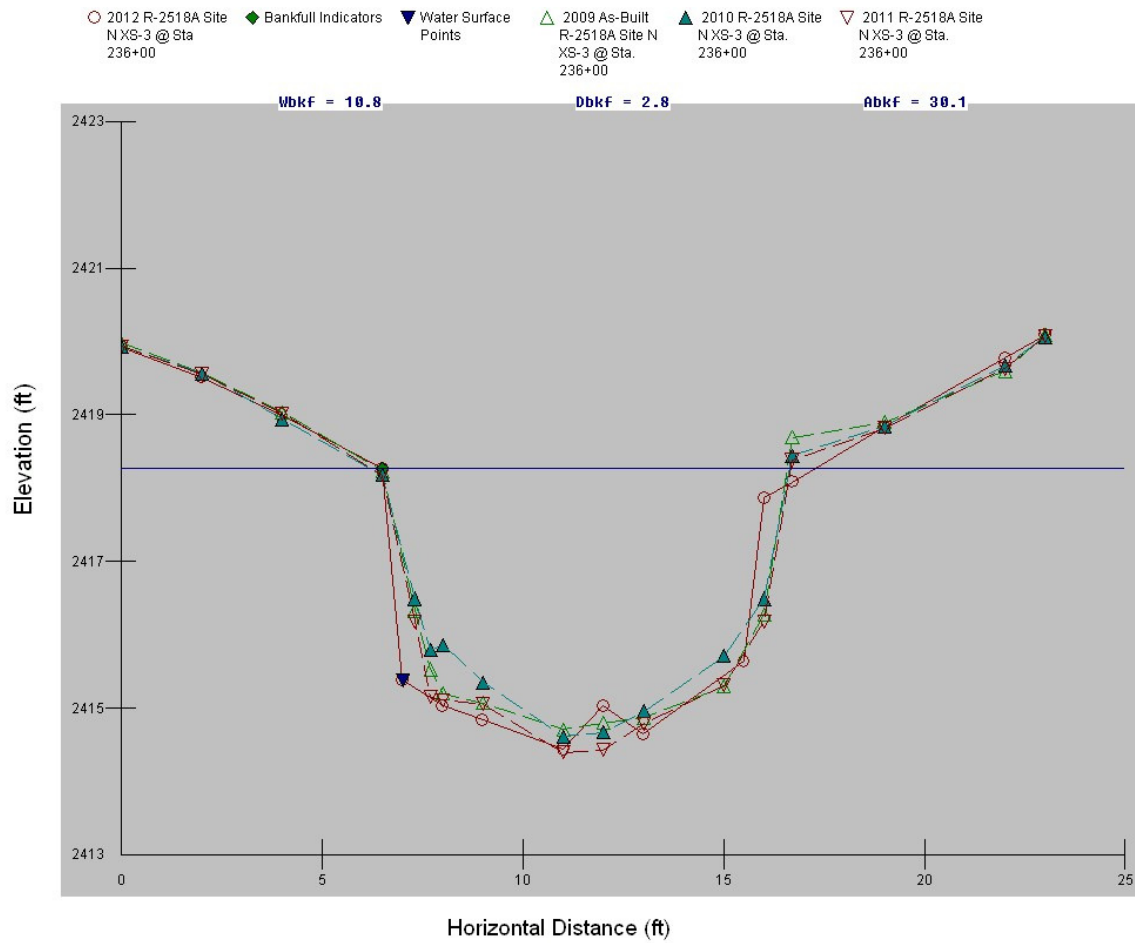
R-2518A Site N XS-3 @ Sta 236+00

Site N: Cross-Section #3 (Pool) Abbreviated Morphological Summary					
	2010	2011	2012	2013	2014
Bankfull Cross Sectional Area (ft ²)	26.36	29.4	30.1		
Maximum Bankfull Depth (ft.)	3.57	3.78	3.82		
Bankfull Mean Depth (ft.)	2.61	2.9	2.8		
Bankfull Width (ft.)	10.11	10.14	10.75

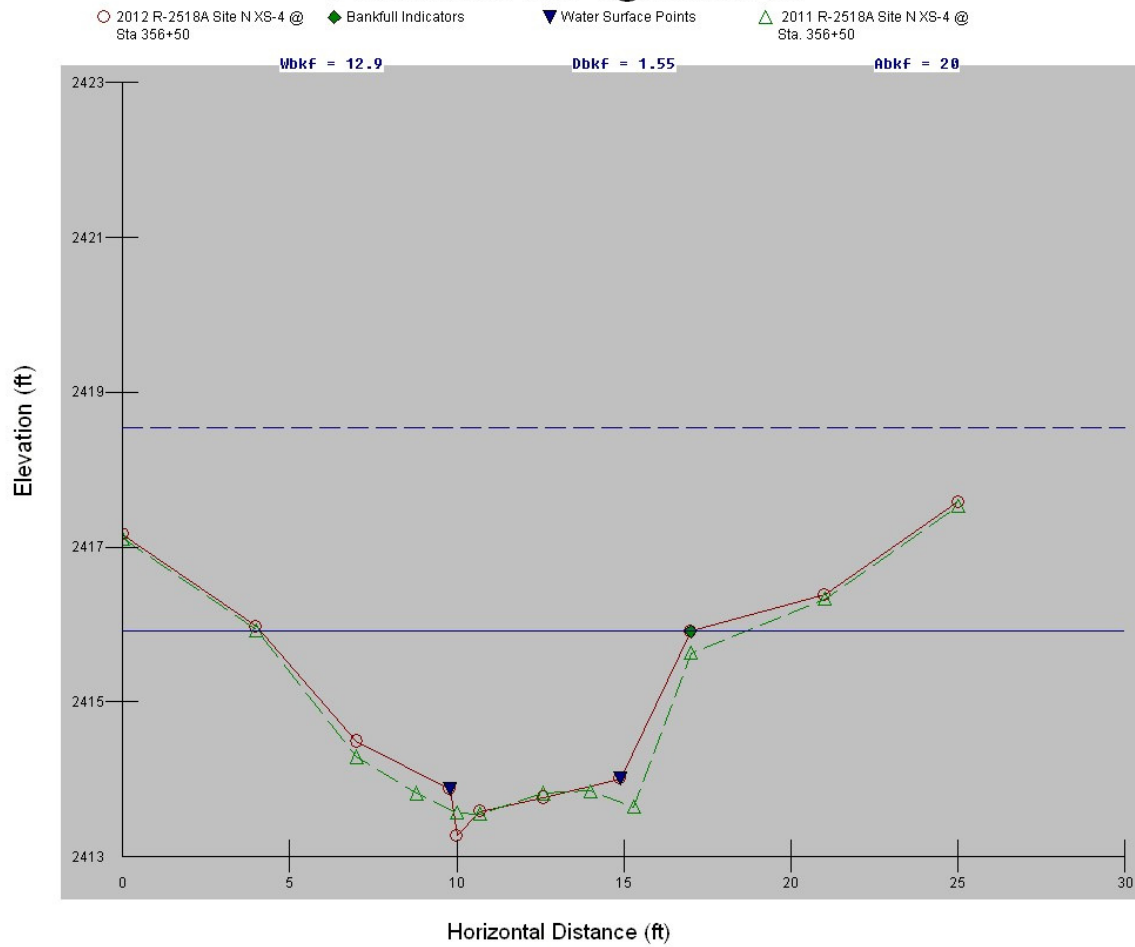
R-2518A Site N XS-4 @ Sta 356+50

Site N: Cross-Section #4 (Riffle) Abbreviated Morphological Summary				
	2011	2012	2013	2014
Bankfull Cross Sectional Area (ft ²)	18.6	20		
Maximum Bankfull Depth (ft.)	2.08	2.64		
Width of the Floodprone Area (ft.)	25	25		
Bankfull Mean Depth (ft.)	1.49	1.55		
Width/Depth Ratio	8.36	8.31		
Entrenchment Ratio	2.01	1.94		
Bankfull Width (ft.)	12.45	12.88

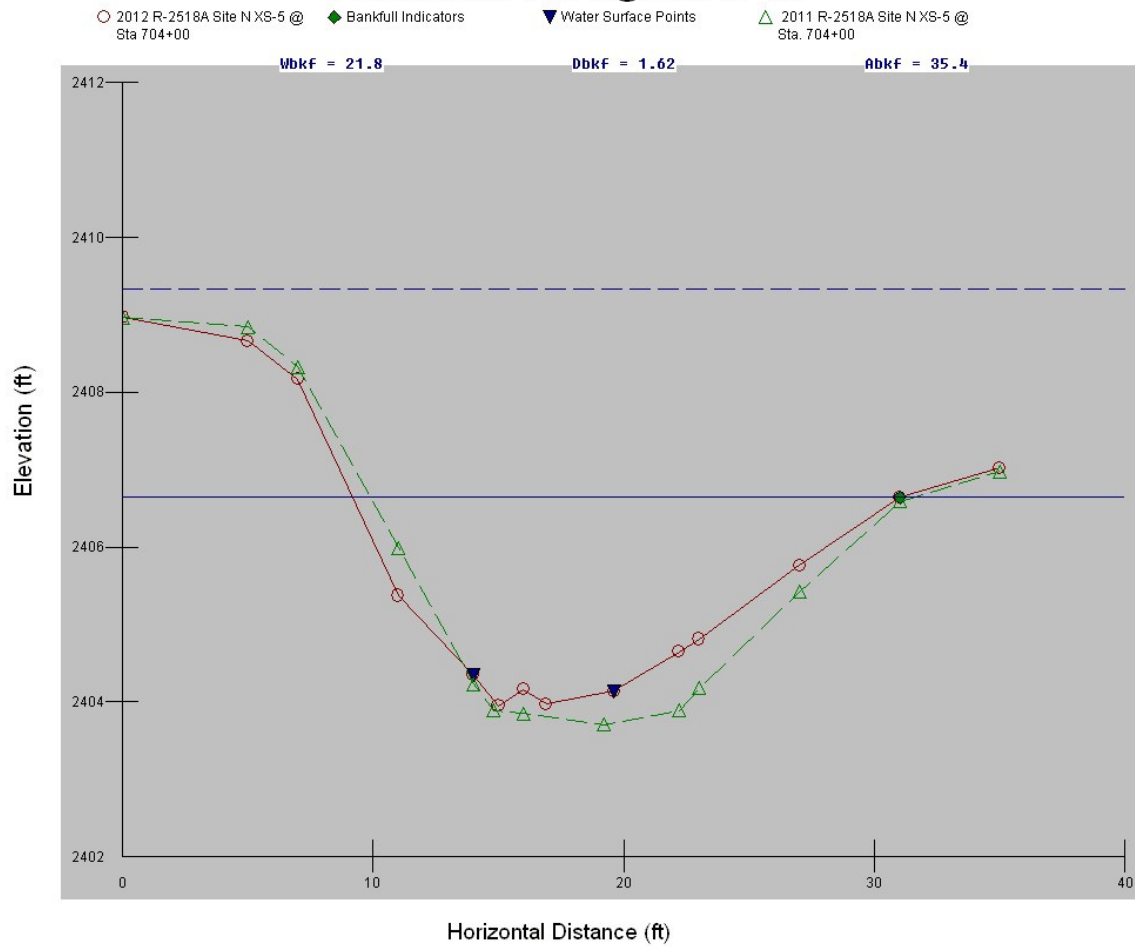
R-2518A Site N XS-5 @ Sta 704+00

Site N: Cross-Section #5 (Riffle) Abbreviated Morphological Summary				
	2011	2012	2013	2014
Bankfull Cross Sectional Area (ft ²)	38.94	35.43		
Maximum Bankfull Depth (ft.)	2.88	2.69		
Width of the Floodprone Area (ft.)	35	35		
Bankfull Mean Depth (ft.)	1.85	1.62		
Width/Depth Ratio	11.37	13.46		
Entrenchment Ratio	1.66	1.6		
Bankfull Width (ft.)	21.03	21.81

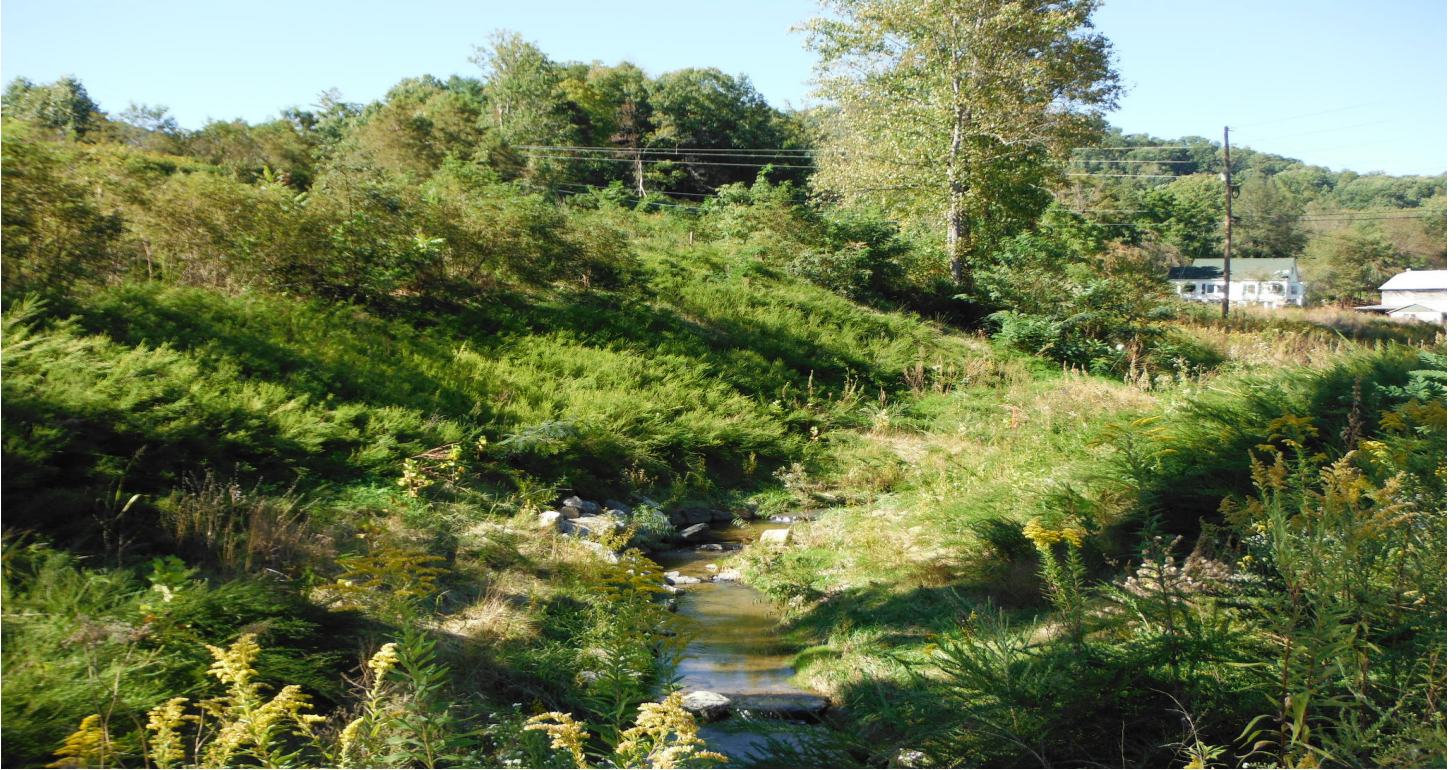
Vegetation Overview Photo (Looking Upstream from US 19)

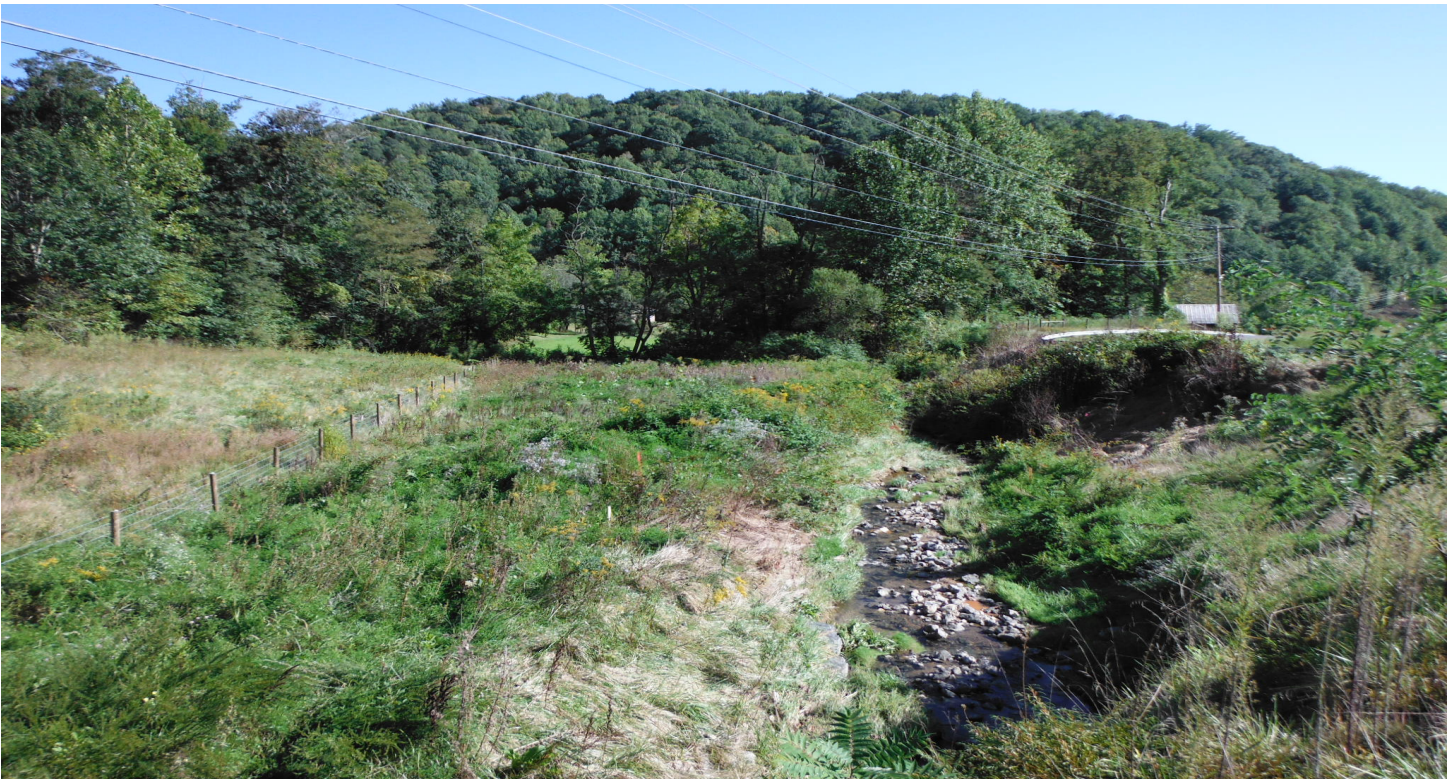
Vegetation Overview Photo (Looking Downstream from US 19)
